Manhole Inspection Summary

Manhole # S49E__006MH

Insp Date: **6/28/08 8:39 AM**

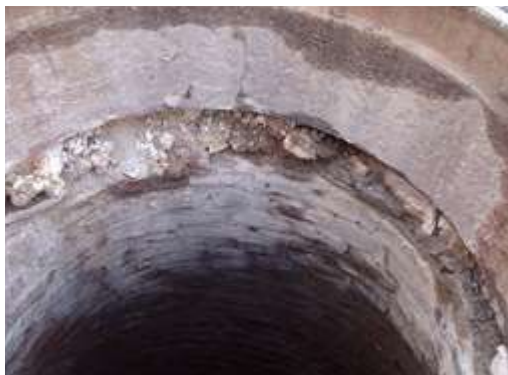
Defect 2

Frame Offset: **1** (in.) Condition: ☐ Sound ☐ Cracked ☒ **Leaks**

frame leaks

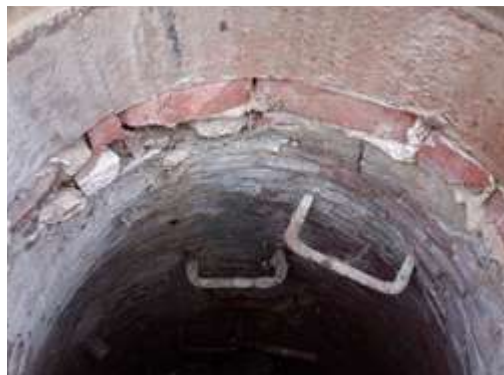
Defect 1

Condition: ☐ Sound ☐ Cracked ☐ Root Intrusion ☒ **Loose Brick** ☐ Deteriorated

Infiltration: ☐ None ☐ Joint ☐ Cracks ☒ **Mortar** ☐ Roots ☐ Wall

loose brick

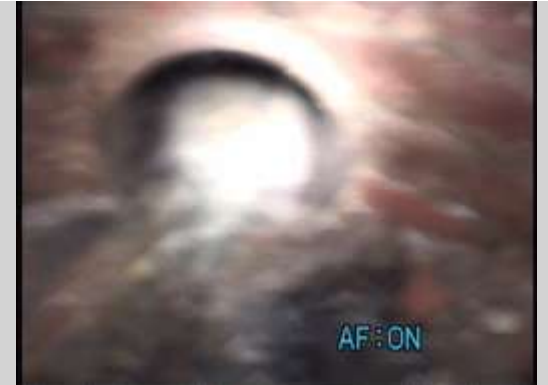
12 O'Clock Outflow

10 in. Circular Gravity Sewer
Pipe Out @ 12 O'Clock

Pipe Height: **10.8** (in.) Rod and Bar (Angled)
Pipe Material: **Clay** ☐ Pipe Lined
Invert Depth: **8.50** (ft.) Flow Characteristics: **Slow**
Deposits: ☒ None ☐ Mud ☐ Sludge ☐ Debris ☐ Grease
Silt Depth: (in.) Deposits Extent:
Infiltration: **None** Pipe Seal Cond: **Sound**
